**BLACKSTONE RIVER BASIN
WORCESTER, MASSACHUSETTS**

**GREEN HILL POND DAM
MA 00149**

**PHASE I INSPECTION REPORT
NATIONAL DAM INSPECTION PROGRAM**

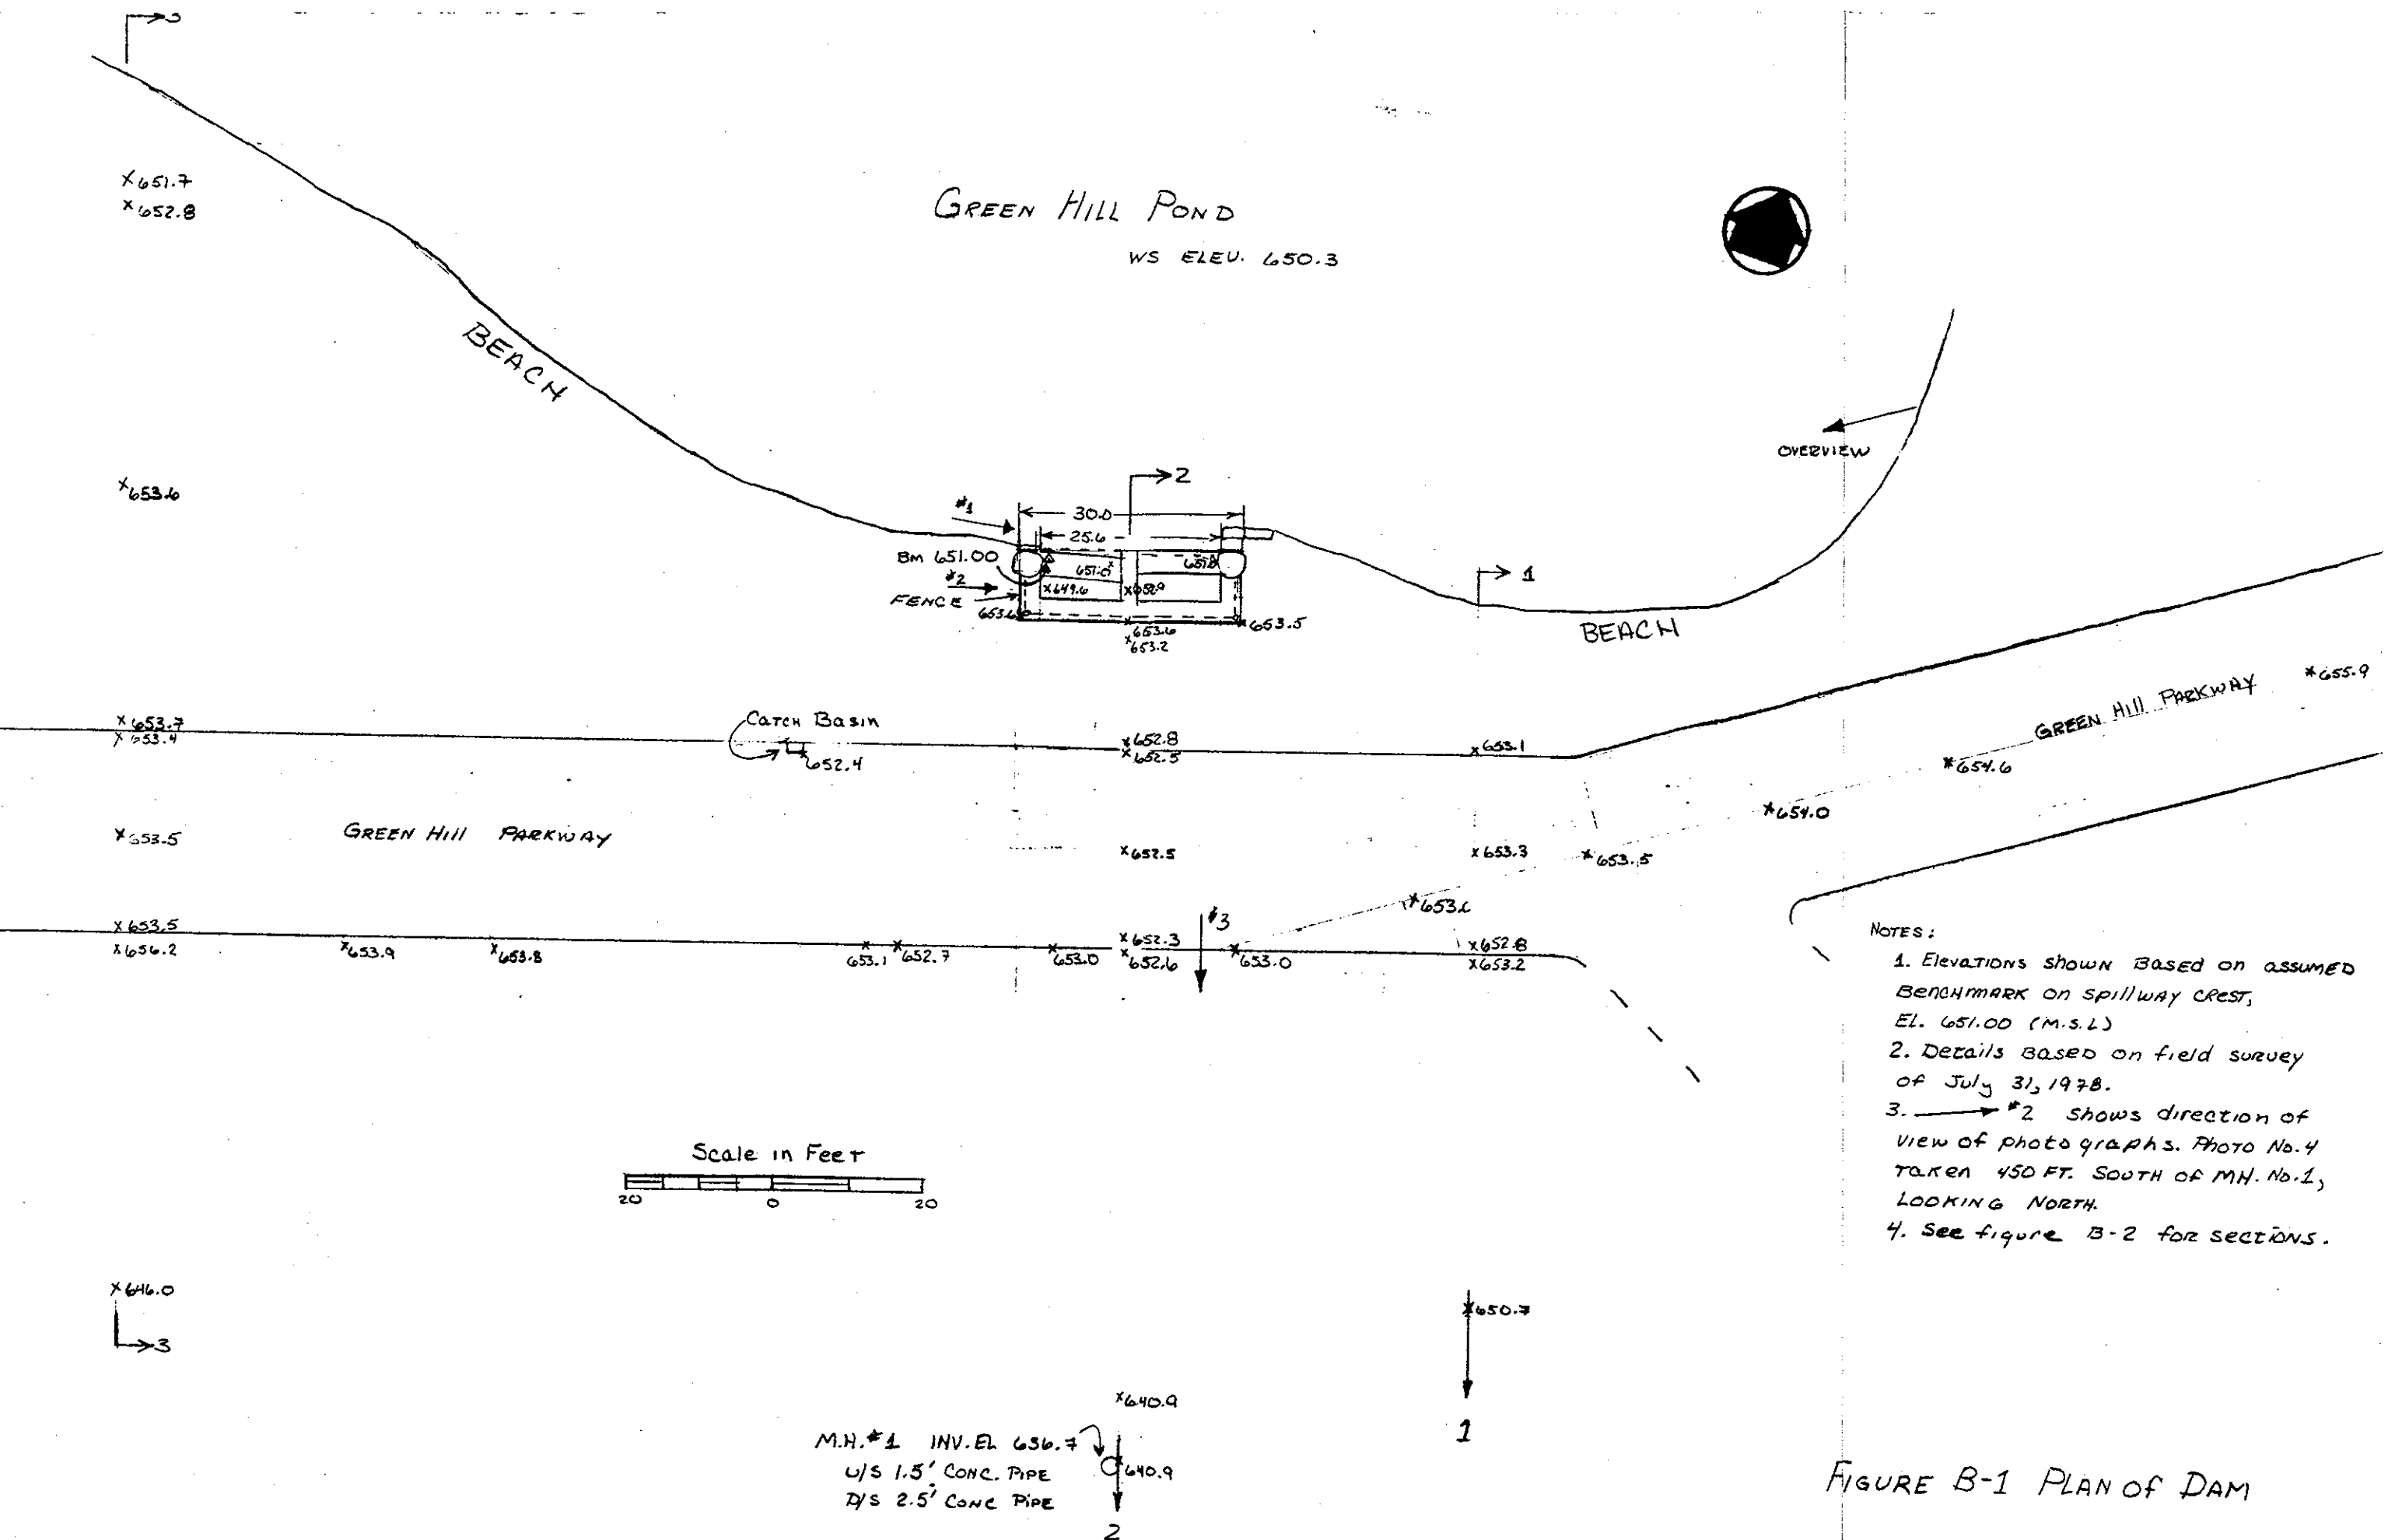
FIGURE B-1 PLAN OF DAM

- b. Description of Dam and Appurtenances. Green Hill Pond dam is an earth fill dam about 200 feet long with a maximum height of 20 feet (see Plan of Dam and Sections, Figures B-1 and B-2). The embankment is founded on bedrock and is constructed of a stone masonry core wall 5 feet thick at the bottom, 2 feet thick at the top, and 17 feet high (see Figure B-4). The remainder of the embankment is earth fill. The crest of the dam is generally about 30 feet wide but increases to about 100 feet wide at the west abutment. The elevation (El) of the crest varies from 652.5 to 654.0. A paved road, Green Hill Parkway, is located on the crest. The upstream slope is 7:1 and is a sandy beach. The downstream slope is 5:1 and is covered with grass.
